Poor Bond Between Heavy Body and Light Body Material

3M ESPE

Making Better Impressions

Guide

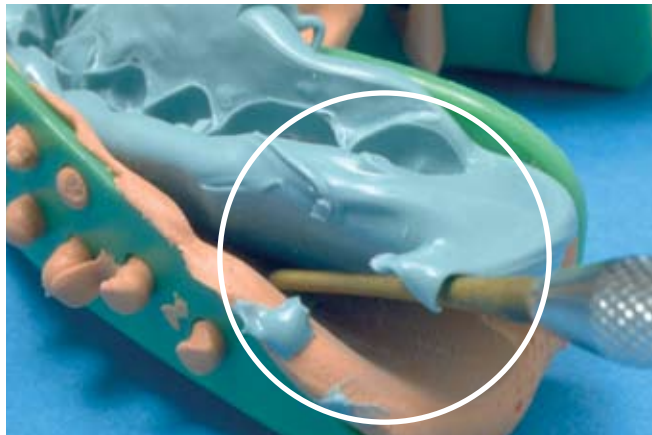
Delamination

Visual Appearance: Heavy body and light body materials not blended, or mixed together.

Result: Restoration will not seat or fit properly.

Exceeding the working time.

Impression material stored at elevated temperature.

Sulfur or acrylic contamination of pre-set heavy body material in two-step technique.

Follow manufacturer's working time specifications.

Choose material with longer working time.

Store impression material at room temperature.

Avoid contact with sulfur contaminants:
Wear gloves proven not to contain traces of sulfur.

Avoid contact with acrylic and methacrylic contaminants: Ensure impression material does not come into contact with methacrylate residue from acrylate temporary materials.
