Making Better Impressions

Trouble

Shooting

Guide

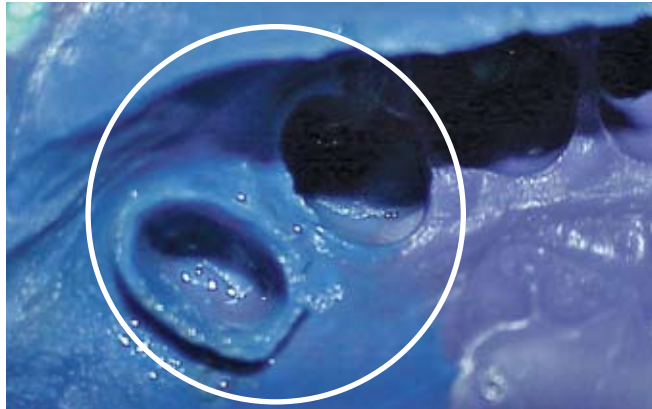
Inhibited Setting

Visual Appearance: Impression not completely set. Shiny, no detail of site.

Result: Inadequate surface detail on stone cast, poor fitting restorations.

Sulfur inhibition due to contact of latex gloves with tissue/tooth/retraction material or impression material.

Residues from custom temporary or provisional cements (acrylics) present.

Wear gloves proven not to contain traces of sulfur.

If contamination is suspected, scrub affected area with diluted hydrogen peroxide.

Do not use impressions already used to fabricate the temporary restoration.

Fabricate the temporary crown or bridge after final impression has been made.

Remove air-inhibited layer on the exposed surface with an alcohol wipe before making final impression.

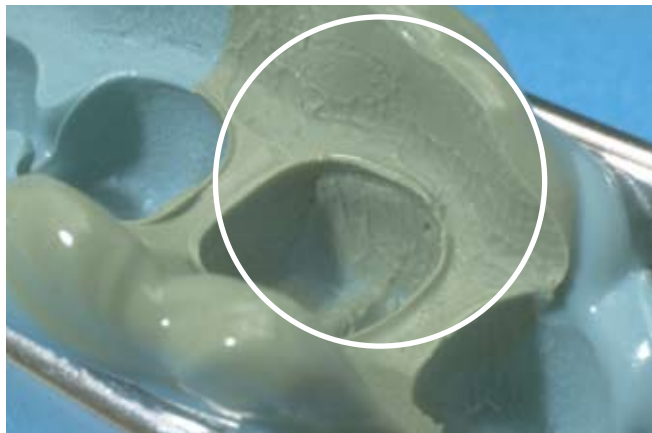
Surface Inhibition

Substances with pH < 4 inhibit setting reaction, most commonly by the contact with acidic retraction materials and hemostatic agents containing epinephrine or ferric sulfates.

Use retraction materials having pH ≥ 4 .

Select retraction materials and hemostatic agents not containing these chemicals.

Rinse, remove, dilute hemostatic solution with water spray and suction. Dry before taking the impression.

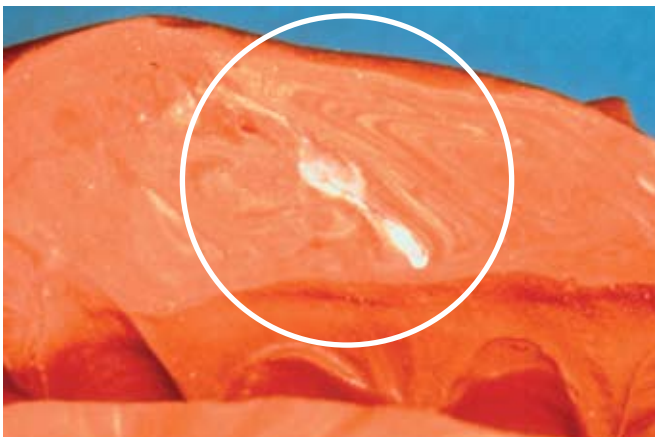
Inadequate Mix

Inadequate mix.

Bleed before applying mix tip to ensure even dispensing.

Use mix tip according to manufacturer's instruction for use.

Ensure mix tip is correctly attached.

When using hand-mix materials ensure correct mixing ratio and thorough mix of catalyst and base paste.
