Poor Bond of Impression Material to the Tray

Making Better Impressions

Trouble

Shooting

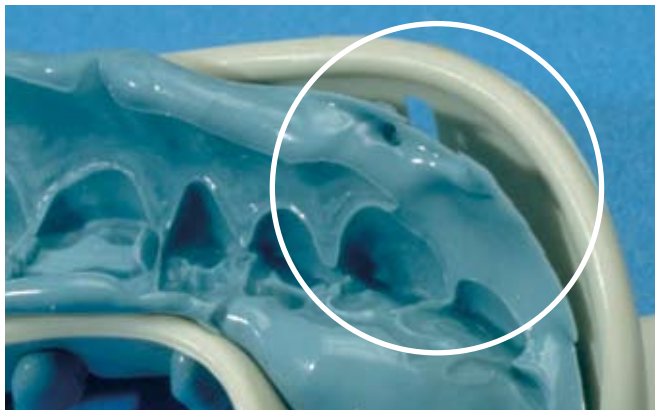
Visual Appearance: Impression pulling away from the sides/bottom of tray.

Result: Crown(s) may be tight and not seat fully, or require excessive internal adjustment.

Separation of Material from Tray

CAUSE	SOLUTION
No tray adhesive used.	Use tray adhesive.
Incompatible tray adhesive used.	Use appropriate tray adhesive. VPS adhesive for VPS. Polyether adhesive for polyether materials.
Inadequate drying time for tray adhesive.	Follow manufacturer's instructions for application, and drying time.
Thin plastic trays allow deflection, which can cause rebound upon removal.	Use a tray that fits better, and is stiffer and more rigid.
