# Voids on the Margin

Making Better Impressions

**Expertise**<sup>TM</sup>  
*Trouble  
Shooting  
Guide*

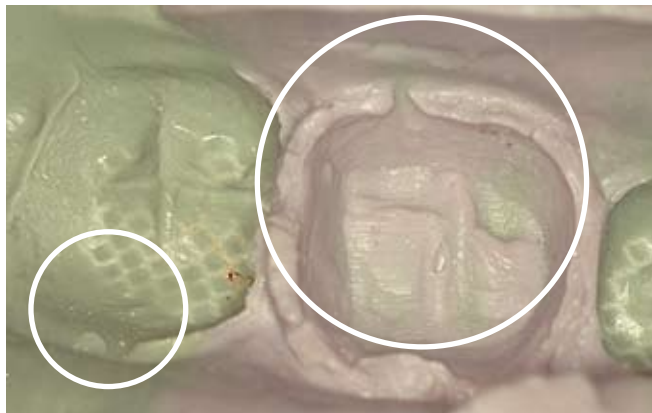
**Visual Appearance:** Voids/holes on margin of the prepared teeth. Incomplete margin.

**Result:** The fit and function of the final restoration may be compromised. Short crown margins and/or open margins.

**Void Caused by Syringe Technique**

CAUSE	SOLUTION
Air trapped in intraoral syringe.	Properly bleed filled elastomer syringe.  Keep tip immersed in material when loading syringe.  Do not stop when in the middle of loading syringe.
Air trapped while filling impression tray.	Keep mix tip immersed in tray material while filling the tray.
Improper syringe technique.	Keep syringe tip immersed in wash material to avoid entrapping air.  Wiggle and stir while syringing. Push material forward.
Inadequate coverage of marginal area with light body impression material.	Use wash material liberally on preparation and abutments.

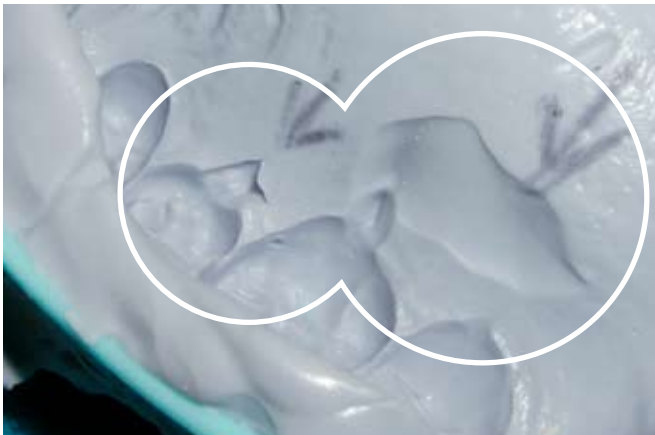
Blood and saliva contamination around prep.

Trapped Air or Moisture

Use good moisture control technique. Rinse and dry prep area before taking the impression.

Stop bleeding by using appropriate retraction technique and hemostatic agent. Leave cord in sulcus until no blood or saliva are present before syringing the light body impression material. Consider two-cord retraction to displace tissue and control fluids.
