Tearing at the Margin

3M ESPE

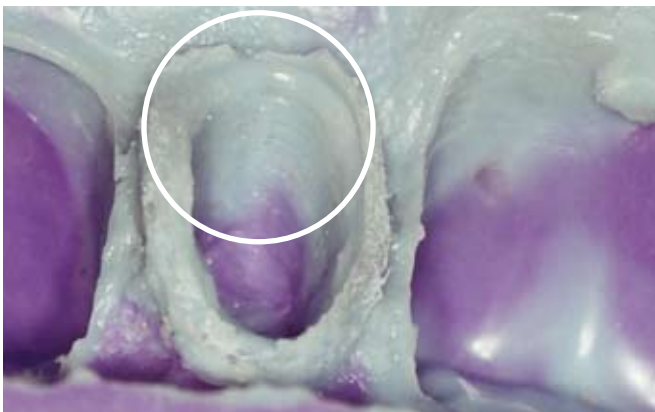
Tearing at the Margin

Visual Appearance: Rip, or visible tearing on the margin of the preparation.

Result: Short crown margins and/or open margins.
